Mobile Intel® Celeron® Processor at 466 MHz, 433 MHz, 400 MHz, 366 MHz, 333 MHz, 300 MHz, and 266 MHz Specification Update

Release Date: March 2002

Order Number: 244444-030

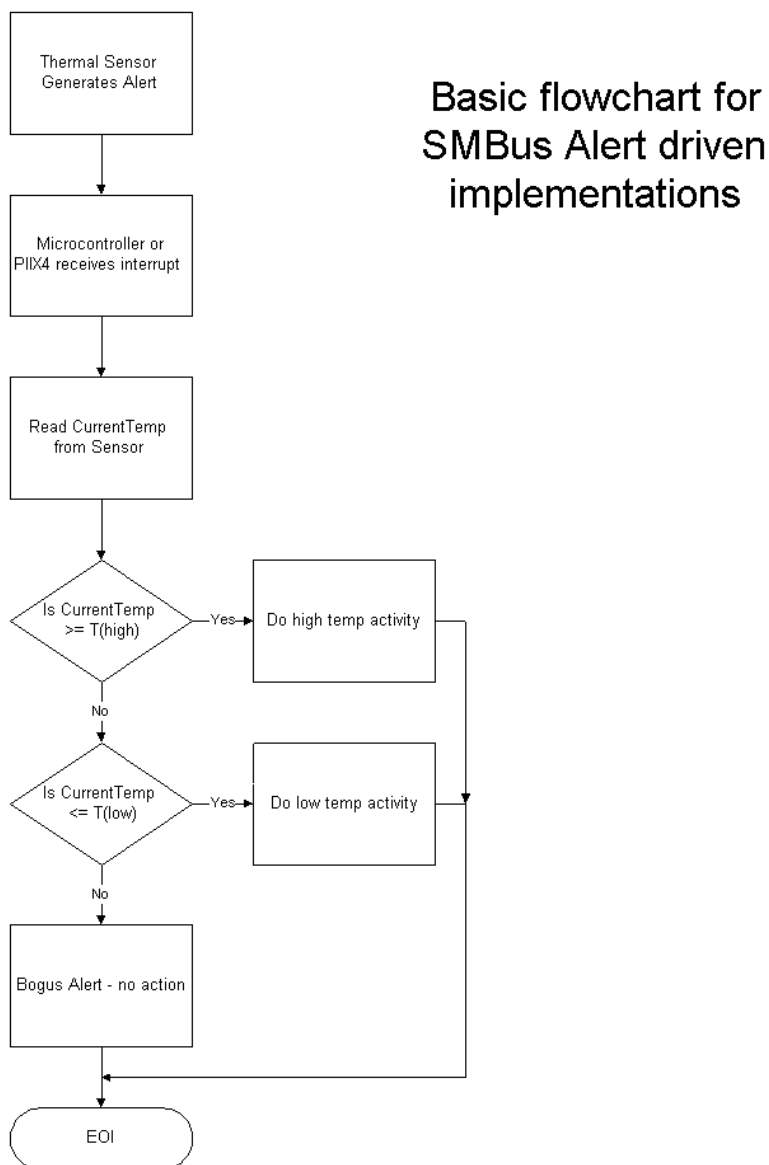
Figure 2. Workaround Flowchart: SMBALERT#-Driven System

H29. Thermal Sensor May Assert SMBALERT# Incorrectly

Problem: The Intel Celeron Processor Mobile Module has a thermal sensor that monitors the processor core's temperature. Please note that desktop systems could have a similar thermal device. The thermal sensor asserts SMBALERT# if the processor temperature exceeds the temperature limits set in the Alarm Threshold Registers (T_{HIGH} , T_{LOW}). It also sets the corresponding Status Register bits to identify the cause of the interrupt. Figure 1 gives one example of the how the SMBALERT# signal could be used in a system.

Implication: There is no system impact from this erratum if temperature polling is used for processor thermal management. If the SMBALERT# interrupt is employed to manage processor thermal sensing, then servicing the false interrupt may result in premature system action depending on the software and hardware implementations used. The rate of the false interrupts is less than the auto-convert rate of the thermal sensor.

Workaround: Three different (mutually exclusive) workarounds are possible:

1. Before servicing an interrupt from the thermal sensor, read and compare the processor thermal reading with the threshold limits (T_{HIGH} or T_{LOW}). Figures 2 and 3 provide basic flowcharts for the implementation of this workaround in an interrupt driven system.
2. If the firmware implemented polls the Status Register only, then before taking any action, re-read the temperature register and do a comparison with the alarm threshold limits (T_{HIGH} or T_{LOW}) to determine if the value is actually still within the temperature window.
3. Use a temperature polling scheme to monitor the processor temperature.
